# **Lane Cove Tunnel**

CO In Tunnel Air Quality Monitoring Validated Report

# 1st December 2018 – 31st December 2018

Report No.: DAT14093

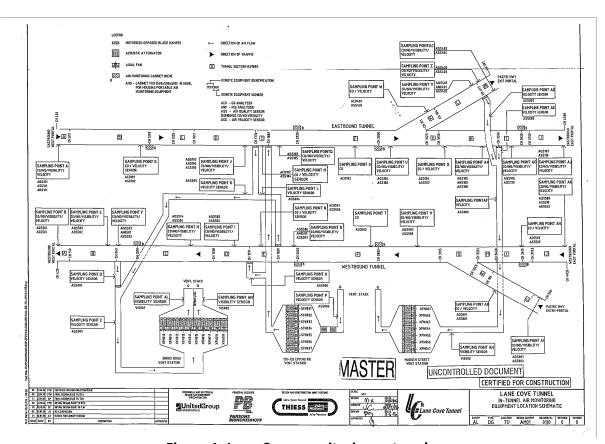
Figure 1: Lane Cove monitoring network

The CO In tunnel monitoring network consists of

• Twenty eight separate CO monitors attached to the walls and portals of both eastbound and westbound tunnels

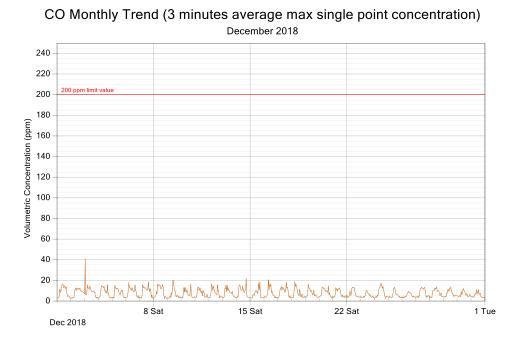
Figure 2: CO exposure and single point 3 minutes rolling averages for December 2018

Validated 1 minute data for CO were used to construct the following monthly graphic representations.

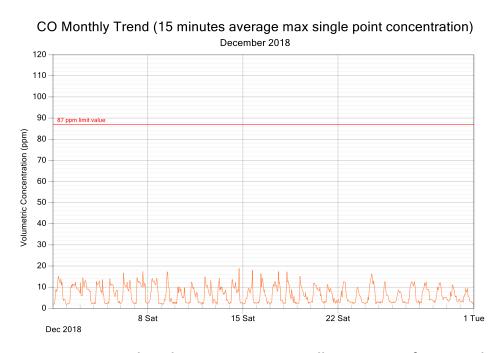
Figure 3: CO exposure and single point 15 minutes rolling averages for December 2018

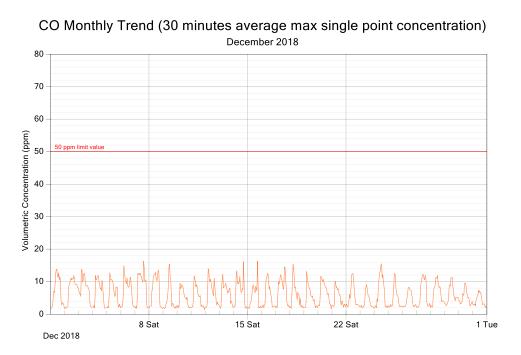
Figure 4: CO exposure and single point 30 minutes rolling averages for December 2018

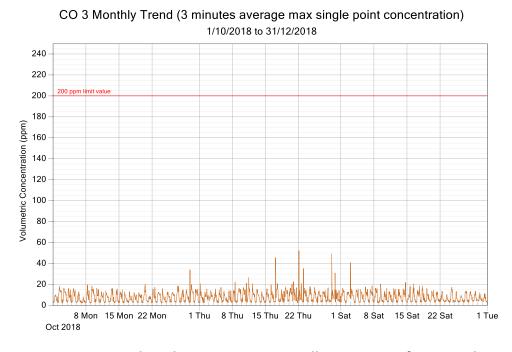
Figure 5: CO exposure and single point 3 minutes rolling averages from October 2018 to December 2018 (3 monthly trend)

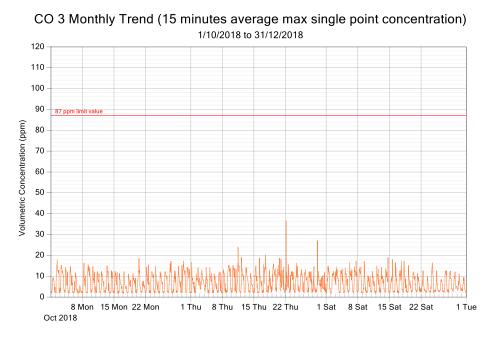
Figure 6: CO exposure and single point 15 minutes rolling averages from October 2018 to December 2018 (3 monthly trend)

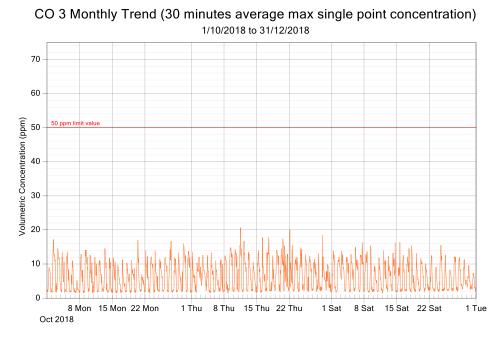
Figure 7: CO exposure and single point 30 minutes rolling averages from October 2018 to December 2018 (3 monthly trend)
