# **Lane Cove Tunnel**

CO In Tunnel Air Quality Monitoring Validated Report

# 1<sup>st</sup> September 2018 – 30<sup>th</sup> September 2018

Report No.: DAT13724

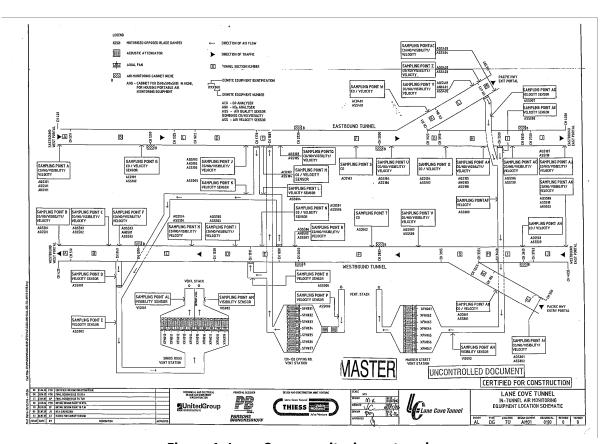
Figure 1: Lane Cove monitoring network

The CO In tunnel monitoring network consists of

• Twenty eight separate CO monitors attached to the walls and portals of both eastbound and westbound tunnels

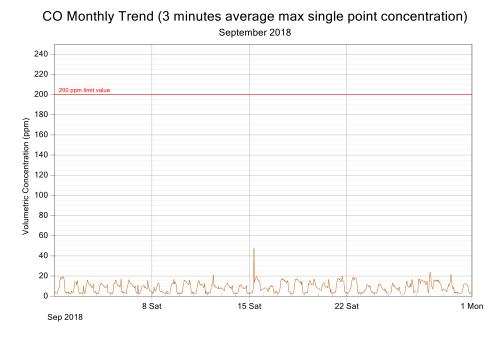
Figure 2: CO exposure and single point 3 minutes rolling averages for September 2018

Validated 1 minute data for CO were used to construct the following monthly graphic representations.

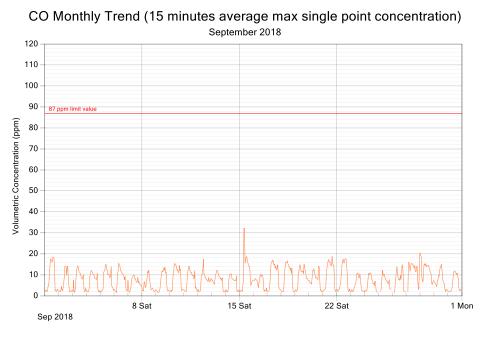
Figure 3: CO exposure and single point 15 minutes rolling averages for September 2018

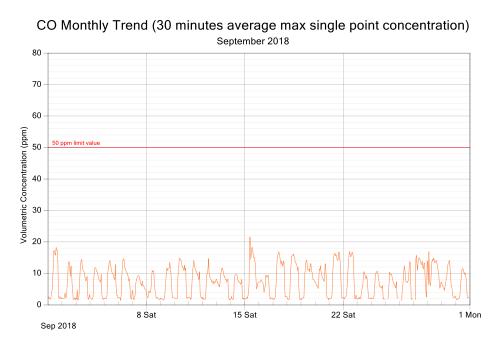
Figure 4: CO exposure and single point 30 minutes rolling averages for September 2018

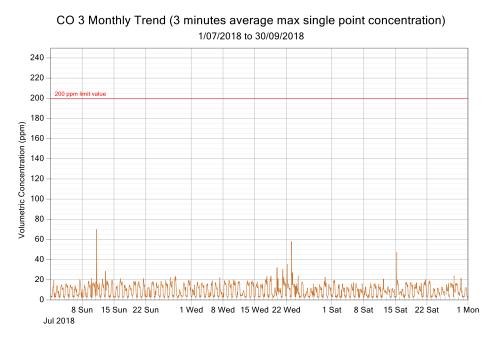
Figure 5: CO exposure and single point 3 minutes rolling averages from July 2018 to September 2018 (3 monthly trend)

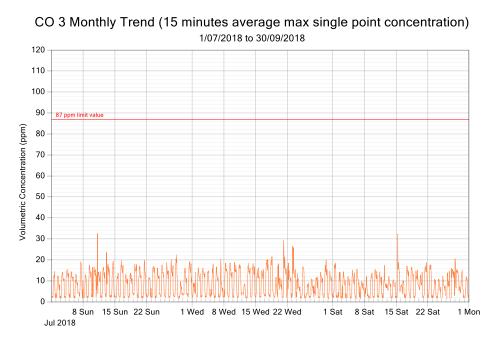
Figure 6: CO exposure and single point 15 minutes rolling averages from July 2018 to September 2018 (3 monthly trend)

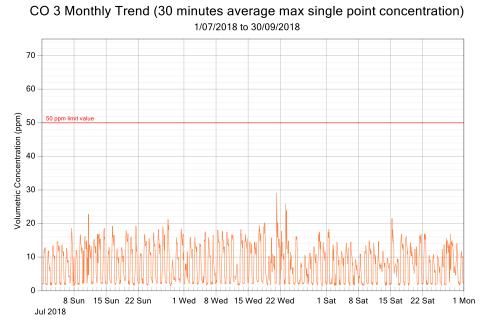
Figure 7: CO exposure and single point 30 minutes rolling averages from July 2018 to September 2018 (3 monthly trend)
